Fish ladder functionality chronology

The following is a timeline of functionality of the fish ladder at the Electron Dam diversion on the Puyallup River. While the fish ladder was not monitored at length for functionality previous to September 22nd, occasional site observations and photos were taken to document the worksite starting on July 15th.

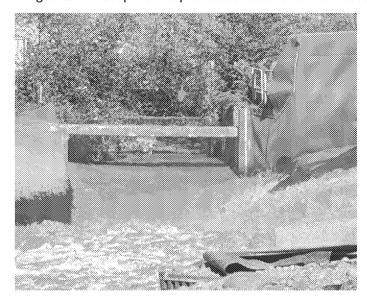
August 17th, 2020

August 17th – Drop from top of ladder falls to the river level begins to become apparent. 775 cfs.

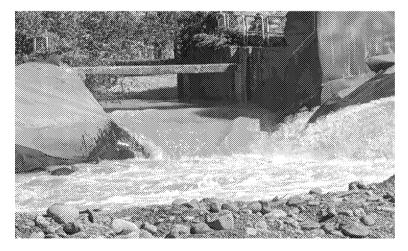
August 27^{th} , 2020 - River at 325 cfs. Fish ladder remains in this condition largely until ladder is adjusted with large rock placed on 10/05/2020.

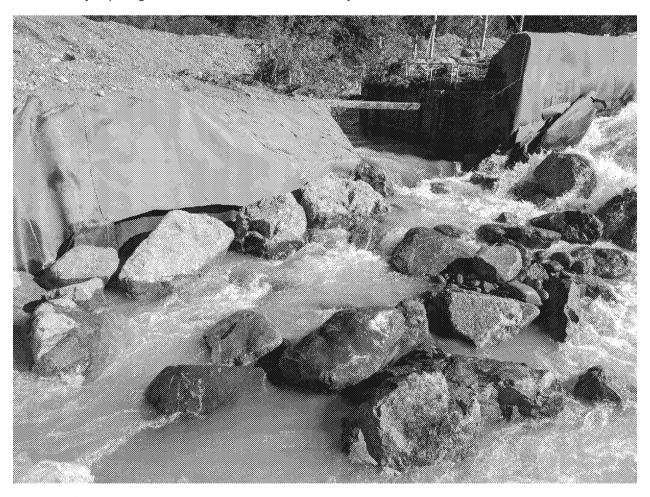
October 5th, 2020, after adjustment

October 5th, 2020 – The fish ladder's lower entrance was adjusted in order to allow fish of all sizes and ages to access the ladder. Adjustments were made by placing two large rock pools just below the ladder to decrease jump height into the lowermost cell. This adjustment was successful.
